# PUBLIC ROADS

A JOURNAL OF HIGHWAY RESEARCH

VOL. 15, NO. 1

MARCH 1934

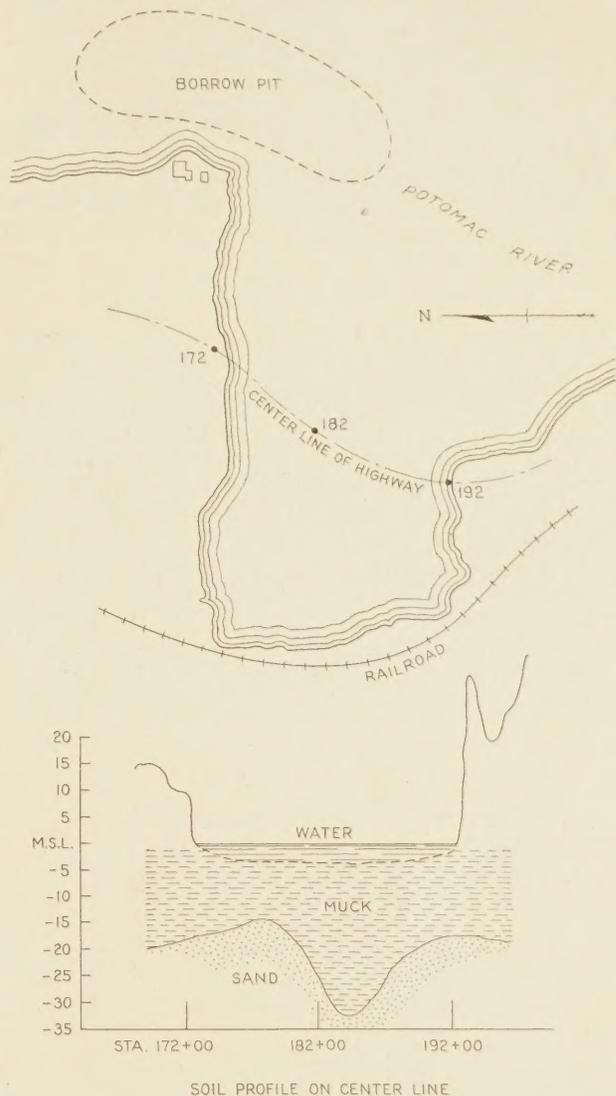
FIGURE 1.—PLAN AND SOIL PROFILE AT FOUR MILE RUN.

The general location of the improvement and the original soil profile on the center line of the road are shown in figure 1. The profile consists of a layer of soft muck 10 to about 30 feet thick resting on a firm sand foundation and is covered with about 3½ feet of water at high tide.

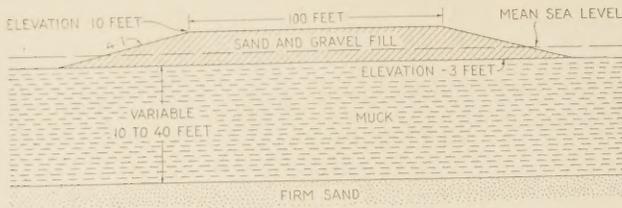
FIGURE 2.—FILL SECTION AS DESIGNED AND CHARACTER OF UNDERSOIL.

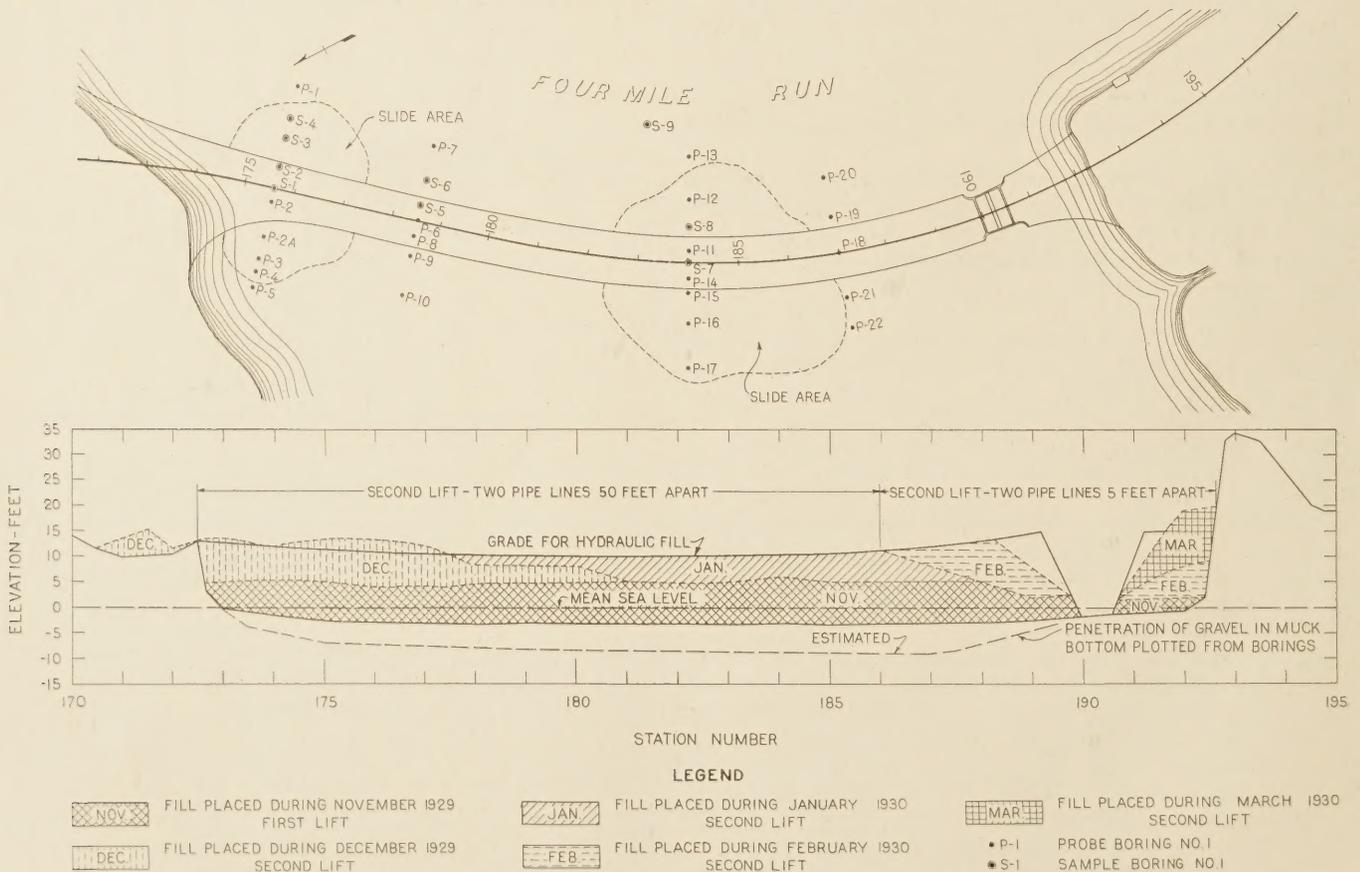
FIGURE 3.—LOCATION OF BORINGS AND PROGRESS IN CONSTRUCTING HYDRAULIC FILL AT FOUR MILE RUN, MOUNT VERNON MEMORIAL HIGHWAY.

The fill was constructed in two lifts as shown in figure 3, which shows also the progress of the work. The cross hatching shows the elevation through which the fill was raised by the two lifts but is not indicative of the quantity of material required in each operation. The total amount of material equals that for the cross hatched area plus that for the space between the bottom of the cross hatching and the broken line shown below. How this additional material was divided between the two lifts is not known.

During the construction of the second lift with the pipe lines separated 50 feet, sliding of large portions of the fill occurred at the two locations designated in figure 3. When the slides began cracks formed around the area adjacent to the discharge pipe and widened as the pumping continued. The fill settled vertically and displacement took place laterally. With the continuation of these phenomena mounds of soft river muck were forced up to a height of as much as 8 feet above the original river bottom thus disturbing the original muck layer for distances of several hundred feet from the center line. The pumping was continued until the lateral flow stopped and the fill reached the required height. Subsequently elevations were measured at regular time intervals in order to determine the rate at which settlement occurred.

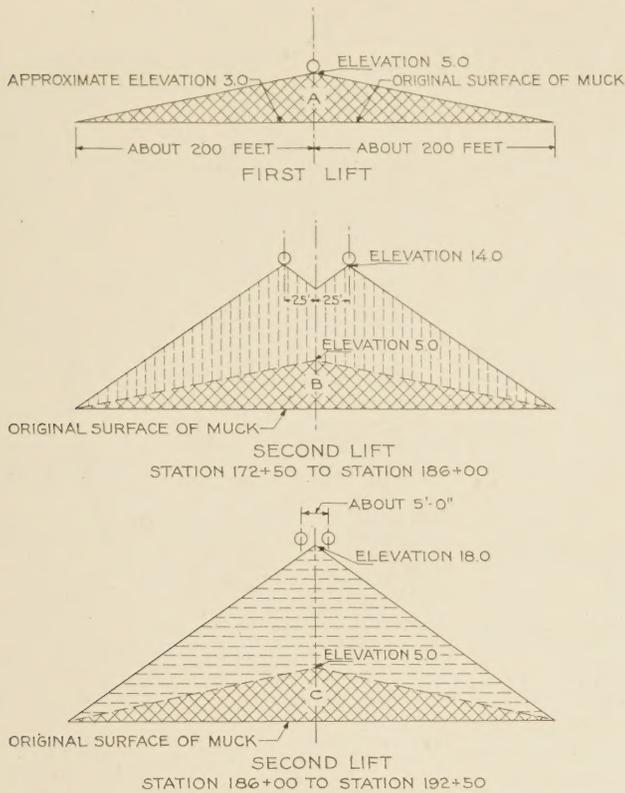
FIGURE 4.—LOCATION OF PIPE LINES AT VARIOUS STAGES OF CONSTRUCTION.

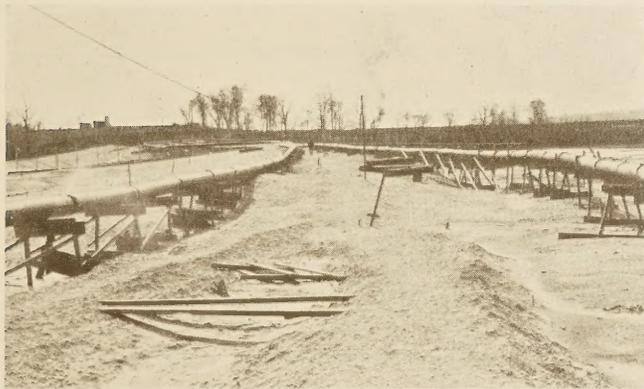
FIGURE 5.—DOUBLE PIPE LINE FOR PLACING SECOND LIFT.

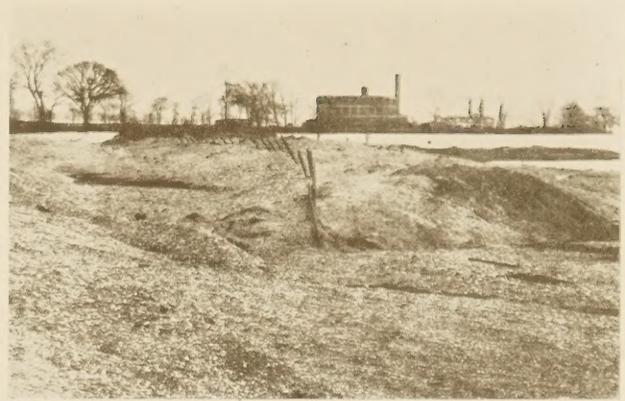
FIGURE 6.—LEFT SIDE OF FILL AT STATION 175+50 SHOWING AREA OF BULGED MATERIAL AND NATURE OF SLIDE. THE ROW OF STAKES IN THE FOREGROUND WAS ON THE SHOULDER LINE OF THE FILL BEFORE THE SLIDE OCCURRED.

Figure 6 shows a mound produced by the slides. A close-up of one of the mounds which shows the character of the displaced river bottom material after exposure to the atmosphere is shown in figure 7. Figure 8 shows the cross sections of the fill at four different locations as indicated by the borings.

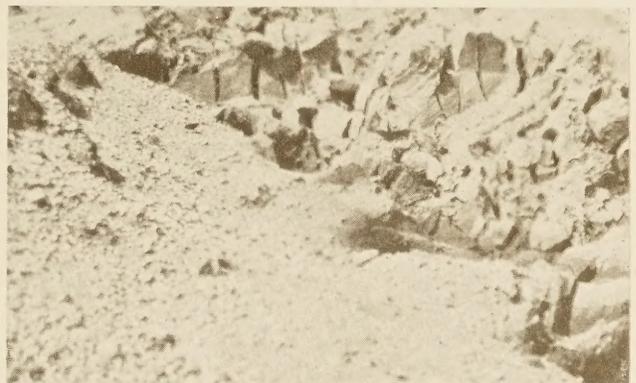
FIGURE 7.—MATERIAL DISPLACED AND SHOVED UP BY SETTLEMENT OF FILL.

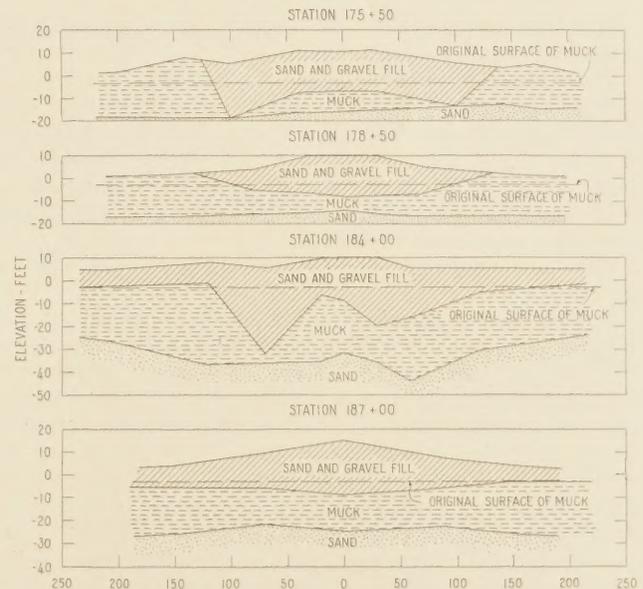
FIGURE 8.—CROSS SECTIONS OF FILL AS INDICATED BY BORINGS.

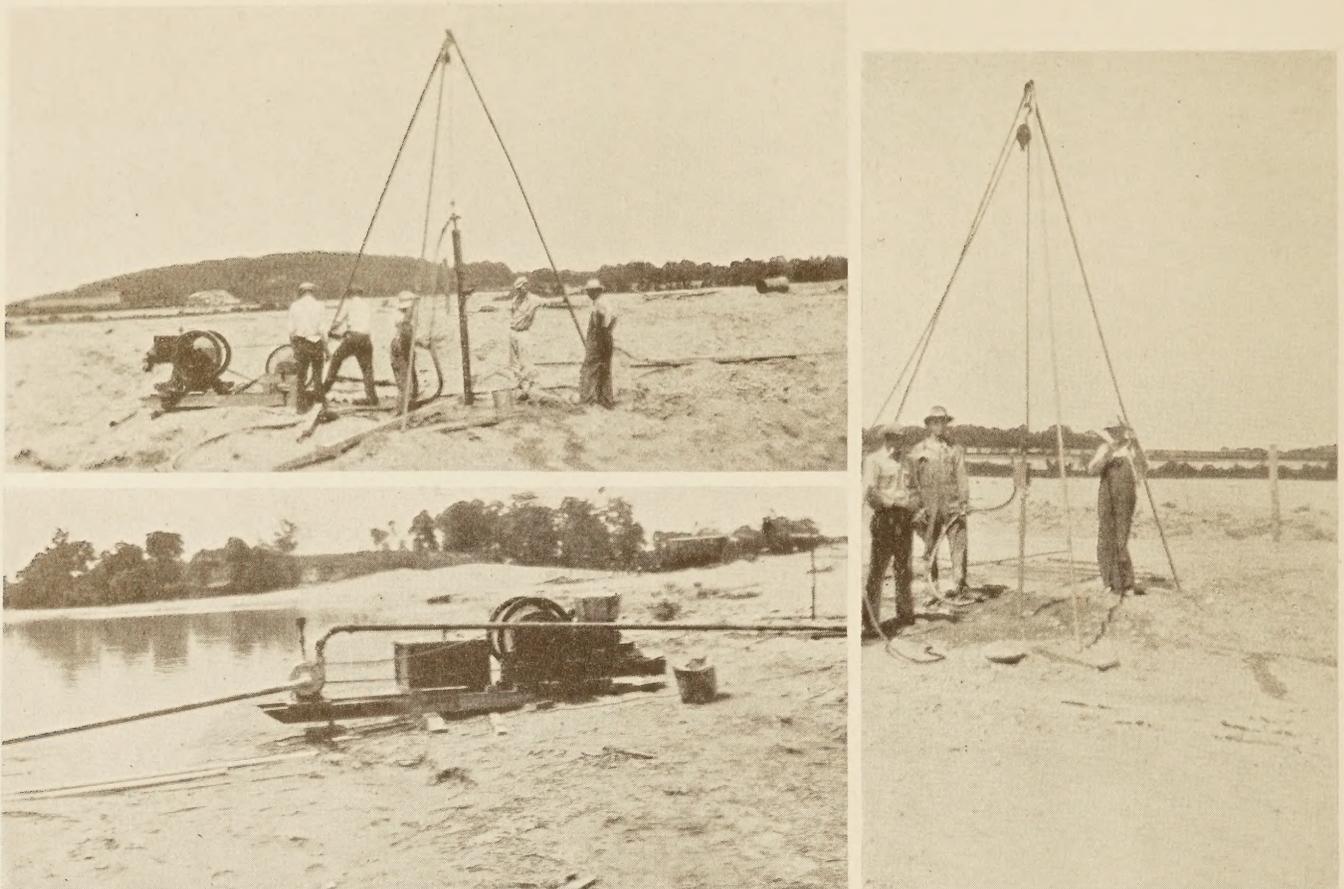
FIGURE 9.—UPPER LEFT—APPARATUS FOR TAKING UNDISTURBED CORES. LOWER LEFT AND RIGHT—APPARATUS FOR PROBE DRILLING.

The "probe" borings were made by driving a 2-inch pipe through the fill material and soft under soil until firm foundation was reached. As the driving proceeded the material penetrated was washed up through the 2-inch pipe by water pumped through a 1-inch drill pipe. These borings indicated only the elevation of the bottom of the fill material and the bottom of the muck. A set-up of this boring equipment is illustrated in figure 9.

The equipment used in driving and washing the casing is illustrated in figure 9.

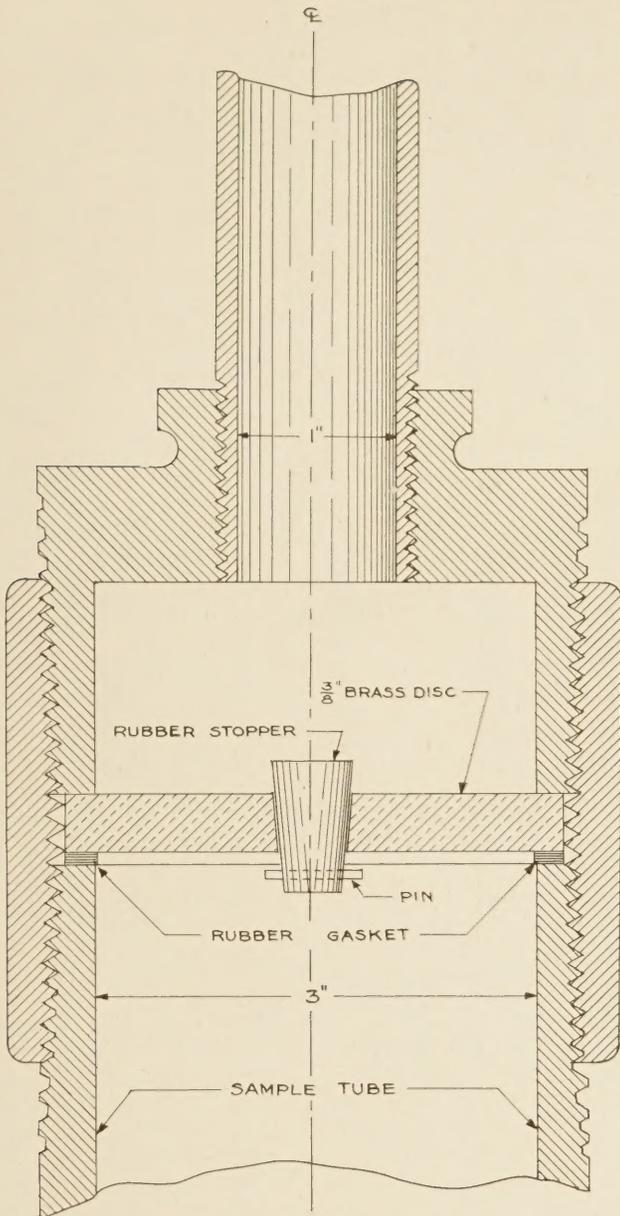
FIGURE 10.—DETAILS OF CHECK VALVE SAMPLING DEVICE.

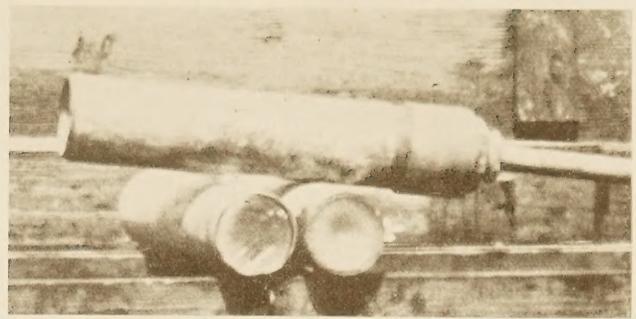
FIGURE 11.—SAMPLING DEVICE FOR OBTAINING UNDISTURBED CORES AND TWO SAMPLES SEALED WITH PARAFFIN.

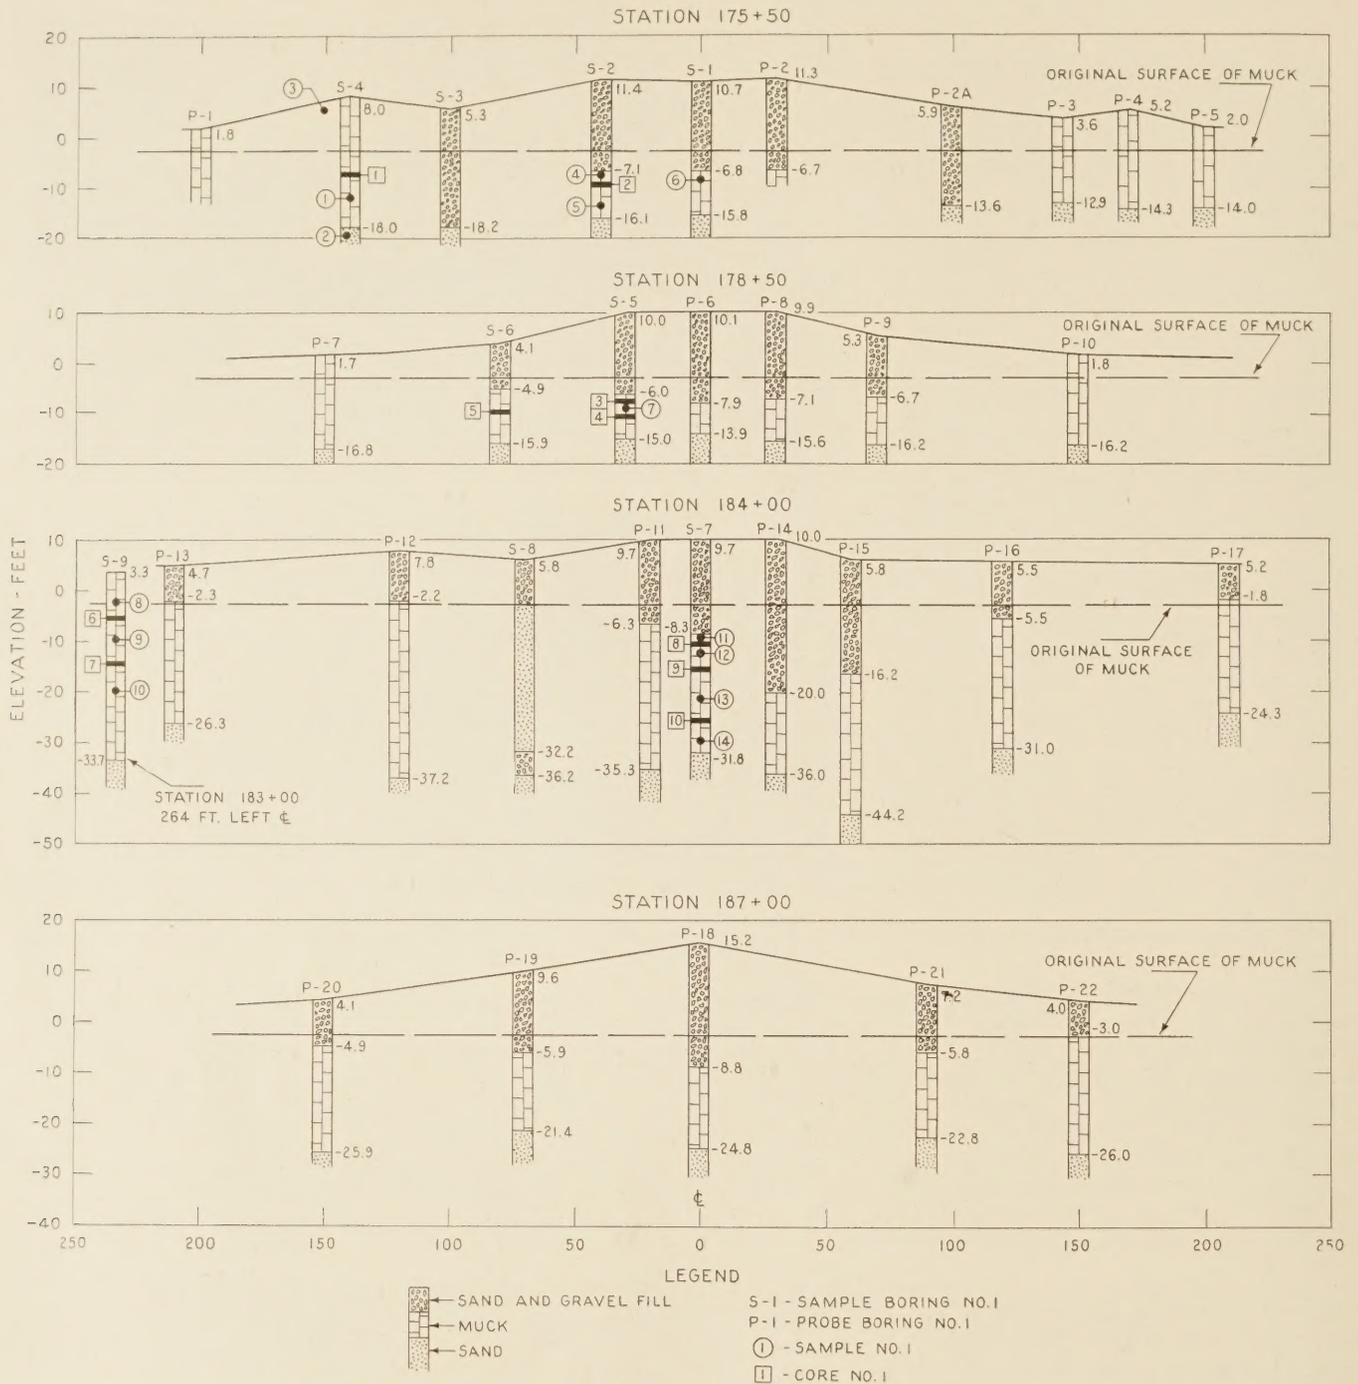
FIGURE 12.—RESULTS OF BORINGS IN HYDRAULIC FILL AT FOUR MILE RUN.

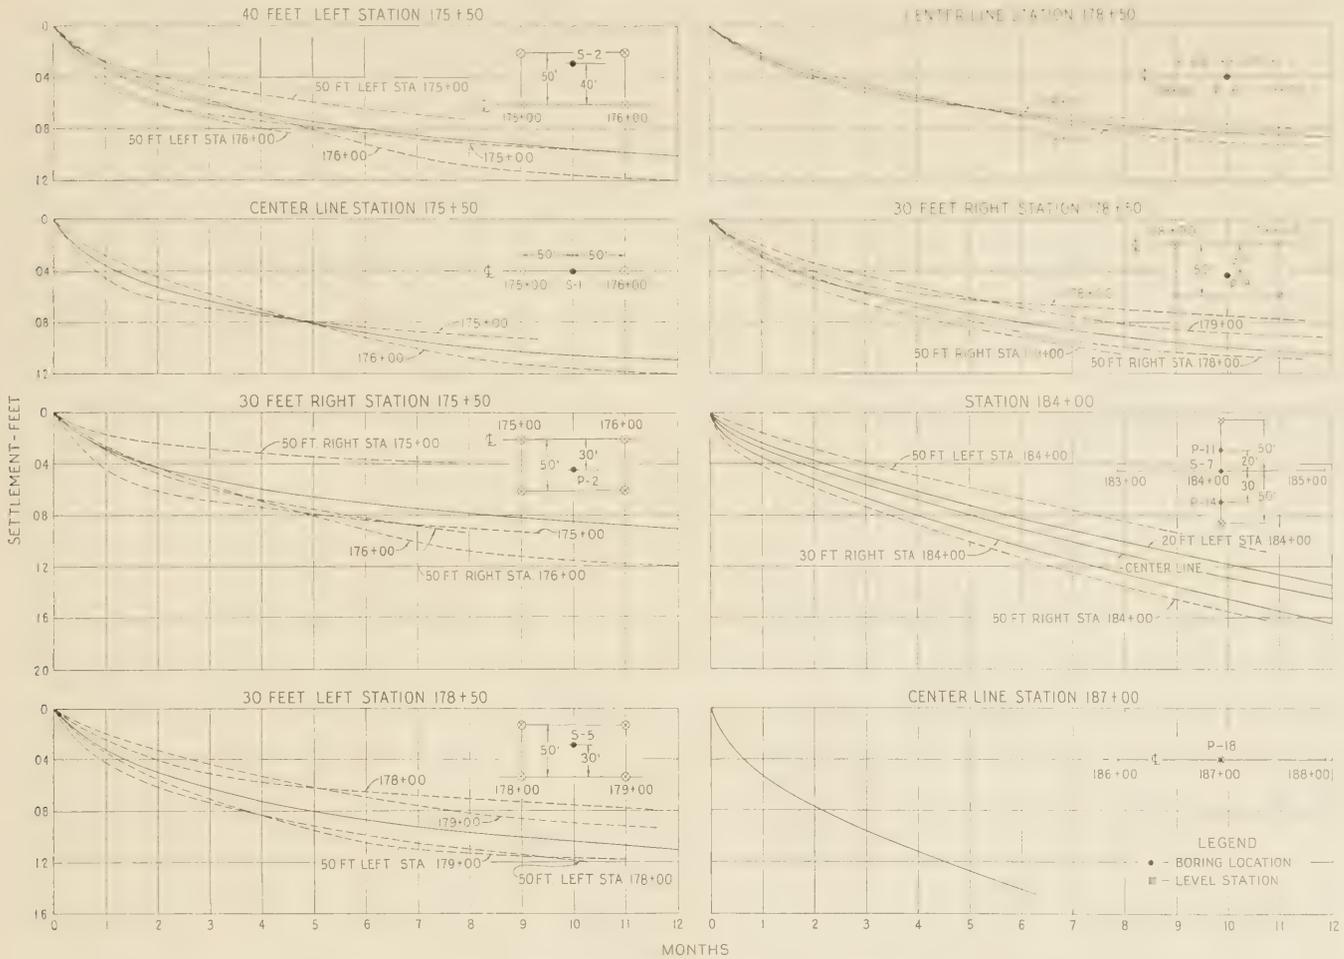
FIGURE 13.—MEASURED AND INTERPOLATED SETTLEMENTS OF FILL.

Figure 13 shows graphically the settlement at drill holes and at level stations in the vicinity of the holes. The sketch with each graph shows the relative positions of the level stations. The broken lines represent the observed settlements as measured with the level while the solid lines show the settlements at the drill hole as

From table 3 and figure 13 it will be observed that there is very little difference in the amount and rate of settlement at stations 175+50 and 178+50 although the moisture contents and liquid limits of cores no. 3 and no. 4 indicate a much more unstable soil at station 178+50 than at station 175+50 which is represented by core no. 2. It appears that a large variation in soil properties as disclosed by these tests may have little influence on settlement.

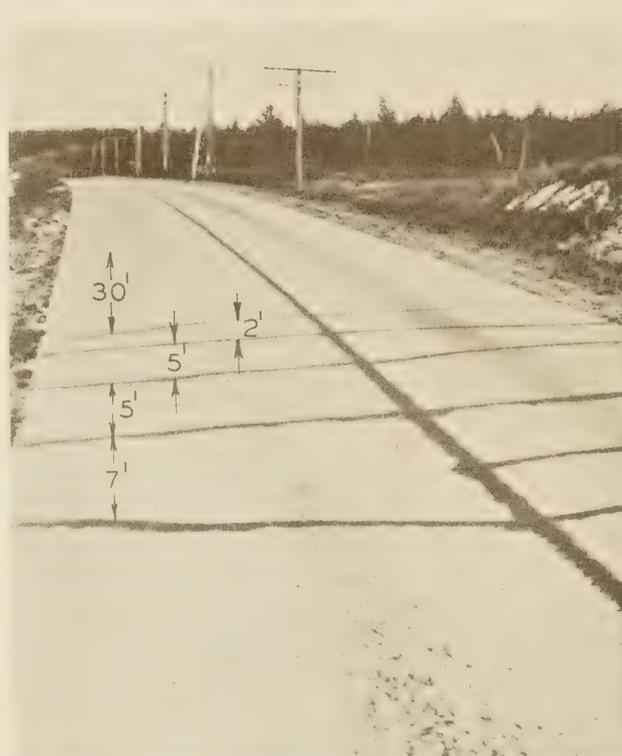
FIGURE 1.—CRACKING IN CONCRETE PAVEMENT DUE TO FROST HEAVE.

**F**ROST ACTION affects road surfaces differently, depending on the type of surfacing. Rigid pavements are heaved and crack in excessive amounts but usually settle back in place after the frost leaves the ground. Successive heaves are often sufficient to break up long slabs of the thinner pavements to such an extent that replacement is required. In semirigid pavements the cracking and breakage due to one period of frost may require considerable patching, if not replacement. Low-type wearing courses, such as gravel, are often entirely lost after one season, the gravel mixing with the soft underoil without furnishing stability. Figures 1 and 2 are examples of damage resulting from frost action.

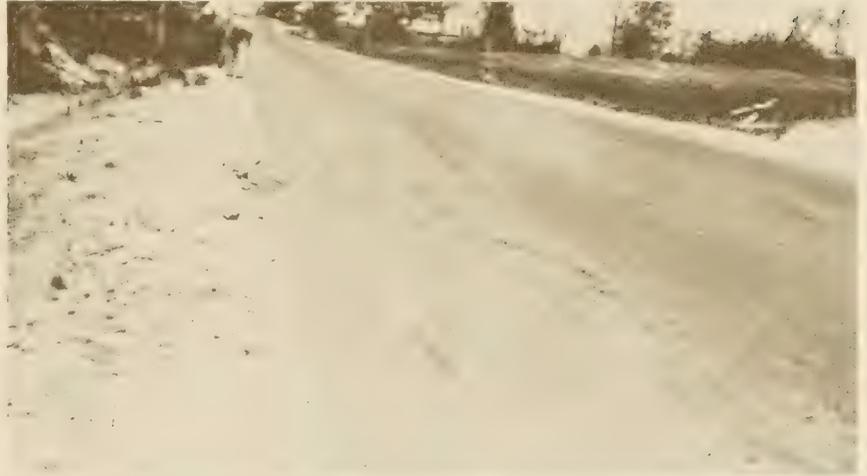
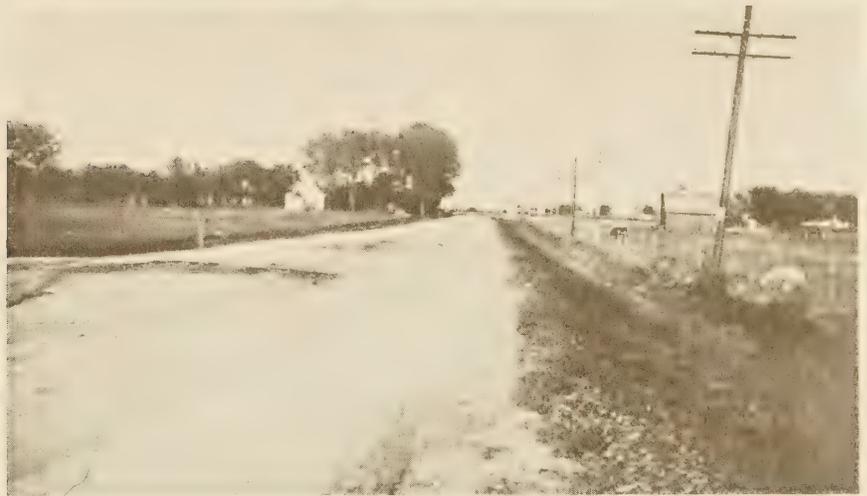
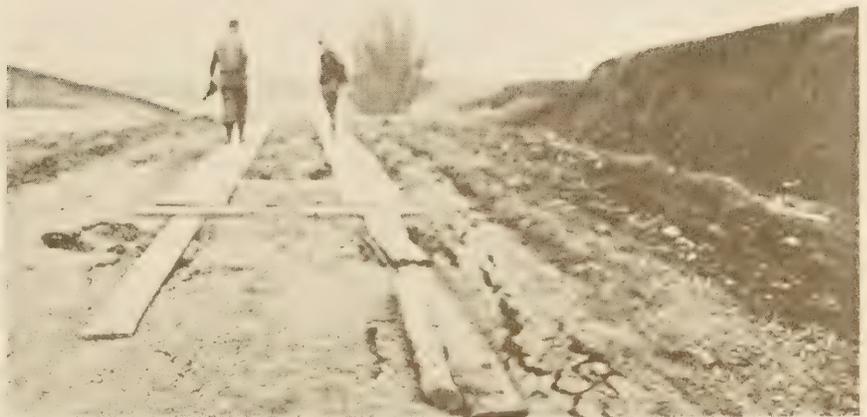
FIGURE 2.—EXAMPLES OF TYPICAL HEAVING.

A Bituminous Surface Damaged by Frost Action.

Effect of Heaving on a Gravel Road.

Heaved Gravel Road at Beginning of Thawing Period. Planks Are Necessary to Prevent Miring.

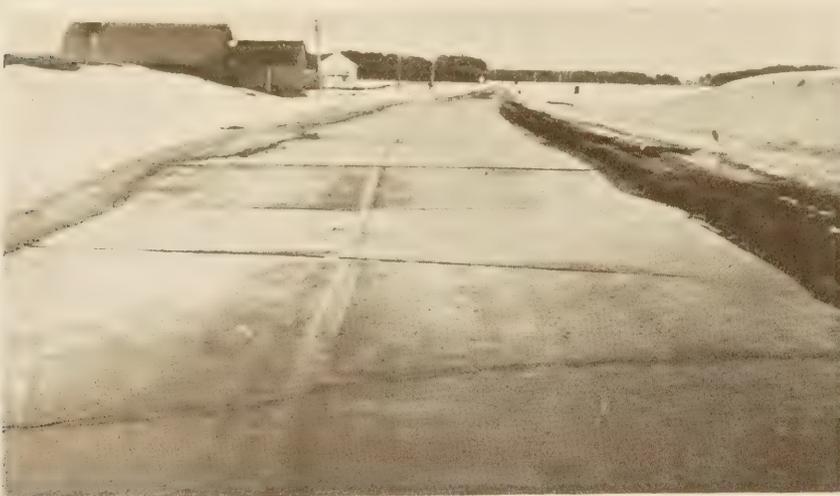
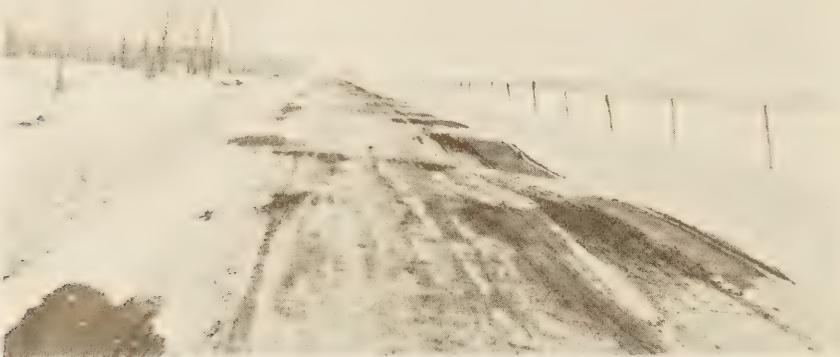
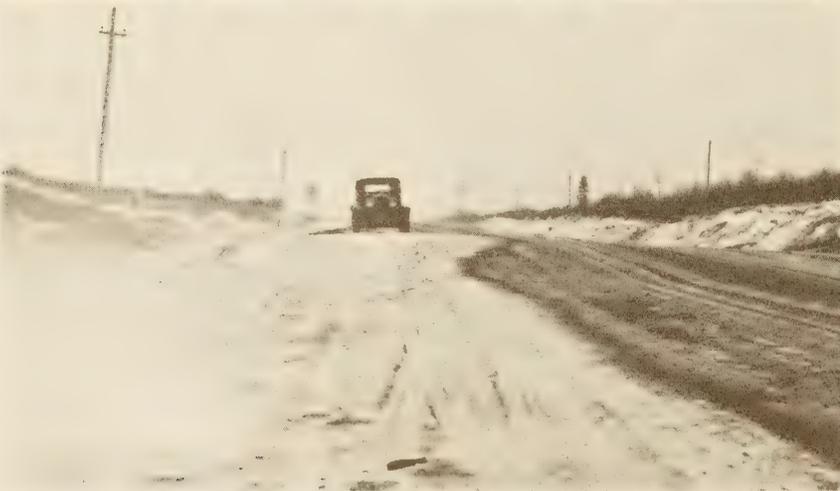
FIGURE 3.—EXAMPLES OF TYPICAL HEAVING.

Abrupt and Hazardous Frost Heave of a Concrete Pavement.

A Series of Frost Heaves of a Gravel Surface.

Prominent Heave in a Gravel Surface.

When heave occurs abruptly there results a hazard to traffic. It is not uncommon for short sections of pavement to heave 10 or 12 inches above the adjacent surface, thus becoming an obstruction capable of causing fast-moving vehicles to leave the road. Examples of such heaves are shown in figure 3.

Figure 5-A illustrates the type of soil profile productive of the heaving shown in the top picture of figure 3. The pockets of silt and silty clay (group A-4 soil) varying in shape and depth occur within a deposit of porous sandy soils (group A-3 soil). The heaving in the silt pocket is excessive while that in the surrounding sandy soils is negligible. Considerable heave occurs

An example of detrimental frost heave in a sandy soil is illustrated in figure 5-C. The sand which varies from fine to coarse in texture and possesses physical properties indicative of the group A-3 soils is maintained in a saturated condition by a water table close to the surface. This is due largely to the topographic features of the adjoining terrain. The road cuts through small knobs or ridges, interspersed with bogs located both at higher and at lower elevations than the roadway. The middle picture of figure 3 is an example of the heaving produced in such a case.

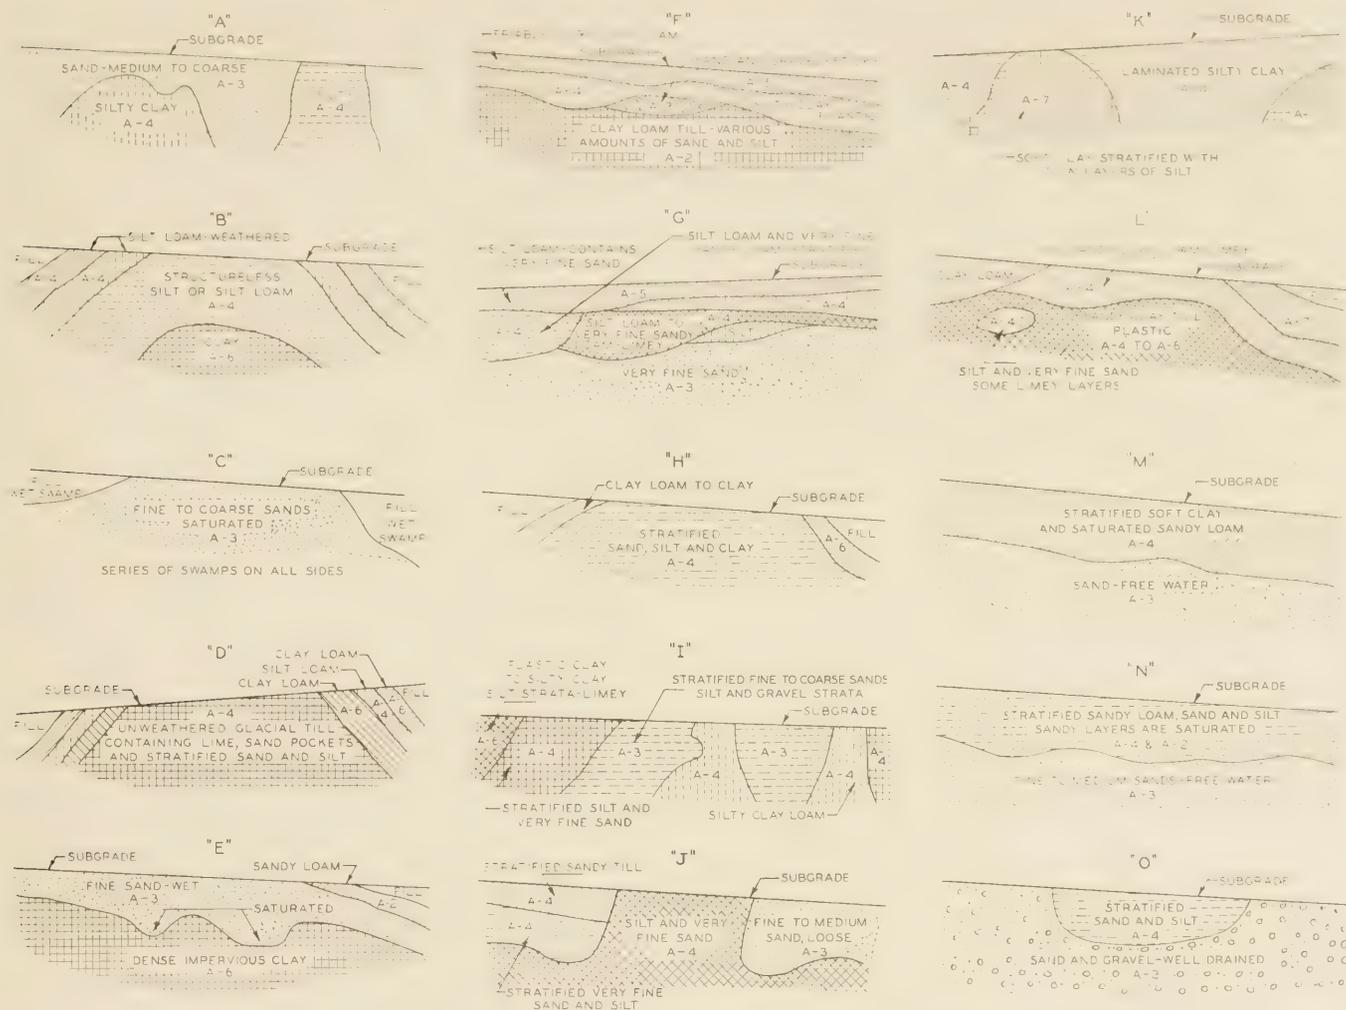
FIGURE 5.—SOIL PROFILES IN WHICH DETRIMENTAL FROST HEAVE HAS BEEN OBSERVED.

Differential heaving of pavements productive of dangerous traffic hazards is generally due to variations in the soil profile. Figure 5 shows the different types of

Figure 5-B shows a typical soil profile in the loessial area of Minnesota and Wisconsin. The frost heave is confined to that portion of the road resting on the unweathered or slightly weathered structureless silt. The weathered upper layers of the profile are granular in structure and apparently do not suffer detrimental frost heave.

A soil profile in extremely variable glacial materials is illustrated in figure 5-D. The relation between frost heave and the various layers of the soil profile is similar to that described for figure 5-B. In this case the heaving occurs in an unweathered glacial till containing lime, sand pockets, and stratified sand and silt. Water is transmitted to the roadway by the capillarity of the glacial till and also by the stratified sand and silt. Considerable amounts of water collect in the sand pockets.

Figure 5-E is an illustration of a soil profile in which heaving occurs as a result of depressions in the surface of an impervious clay. The dense clay restricts percolation of water and maintains the overlying sand in a wet condition while the sags in the surface of the clay layer act as reservoirs for the collection of water in excessive amounts. This condition is productive of the type of heaving shown in the top picture of figure 3 and attributed also to condition 5-A.

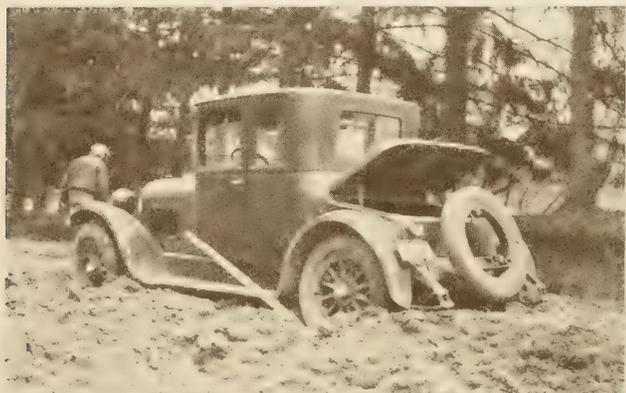
FIGURE 4.—RESULT OF THAW OF A FROST-HEAVED GRAVEL

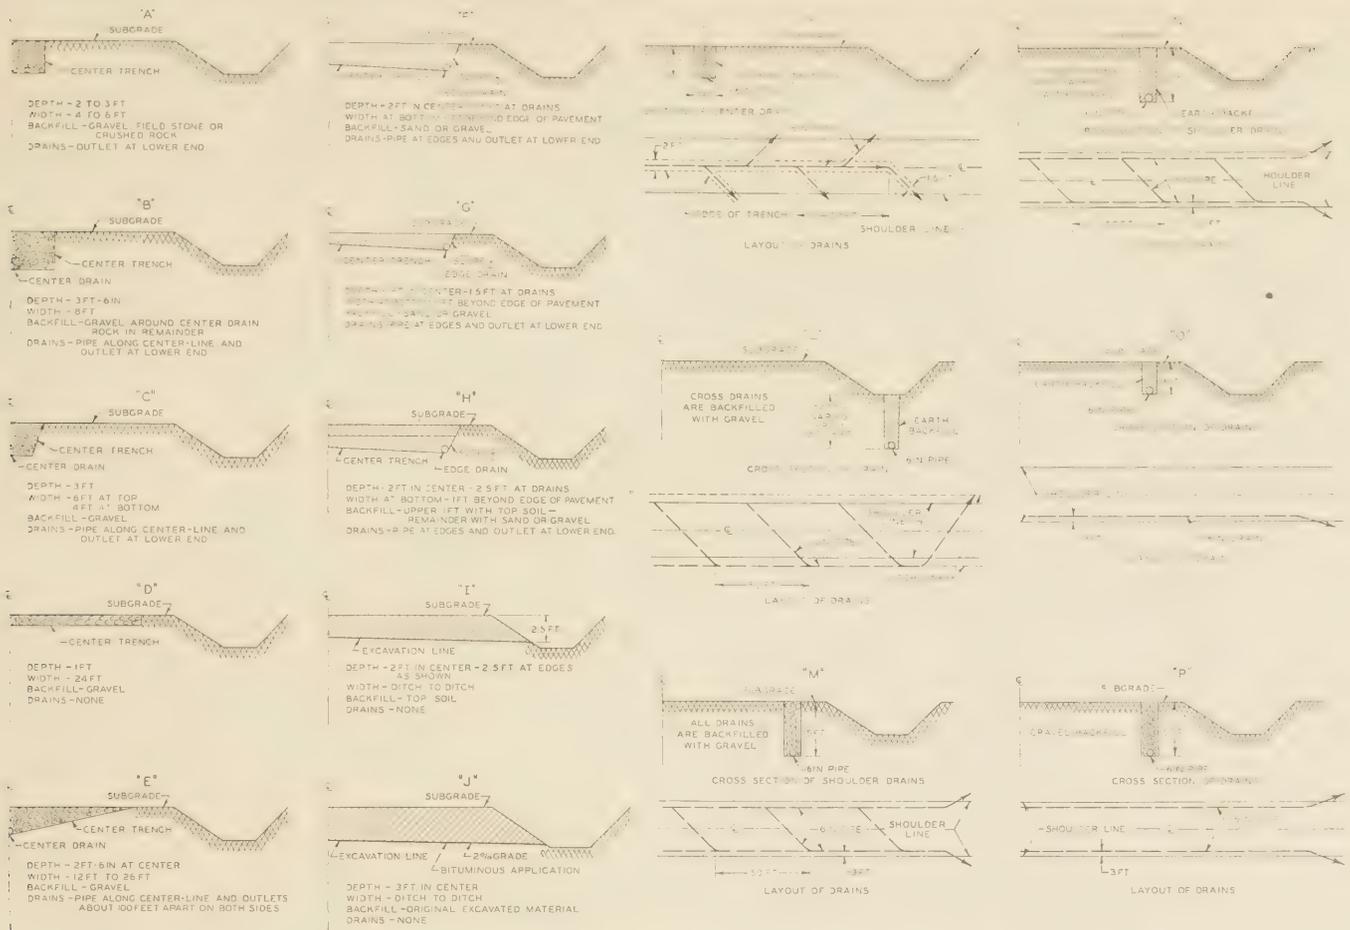
FIGURE 6.—SUBGRADE DESIGNS USED TO PREVENT FROST HEAVE.

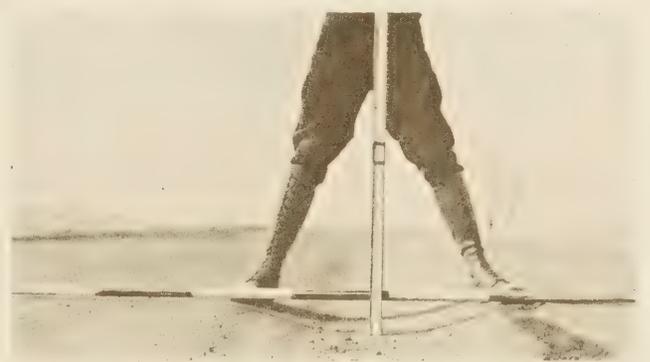
FIGURE 7.—HEAVING AT SIDES OF NARROW TRENCH FILLED WITH GRANULAR MATERIAL.

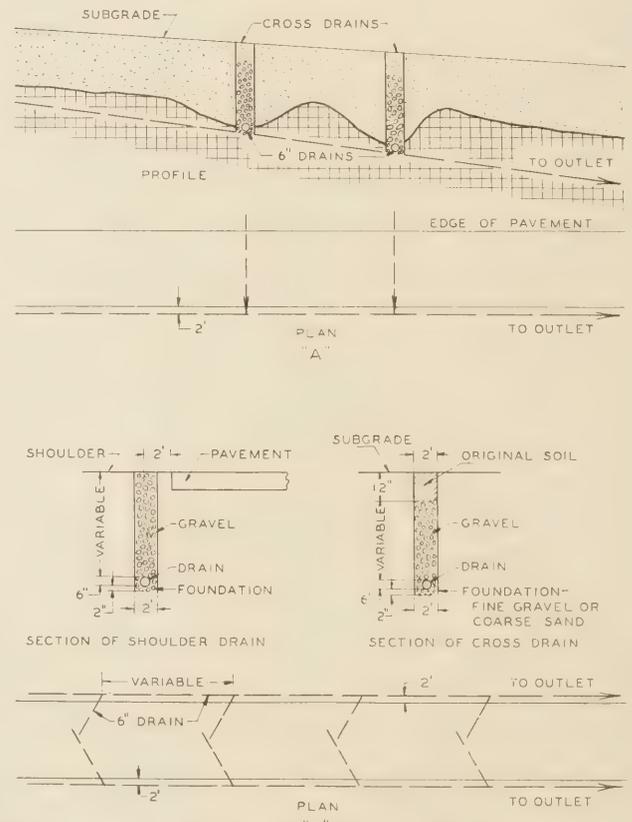
FIGURE 8.—METHOD OF PREVENTING FROST HEAVE IN DRAINABLE SOILS.

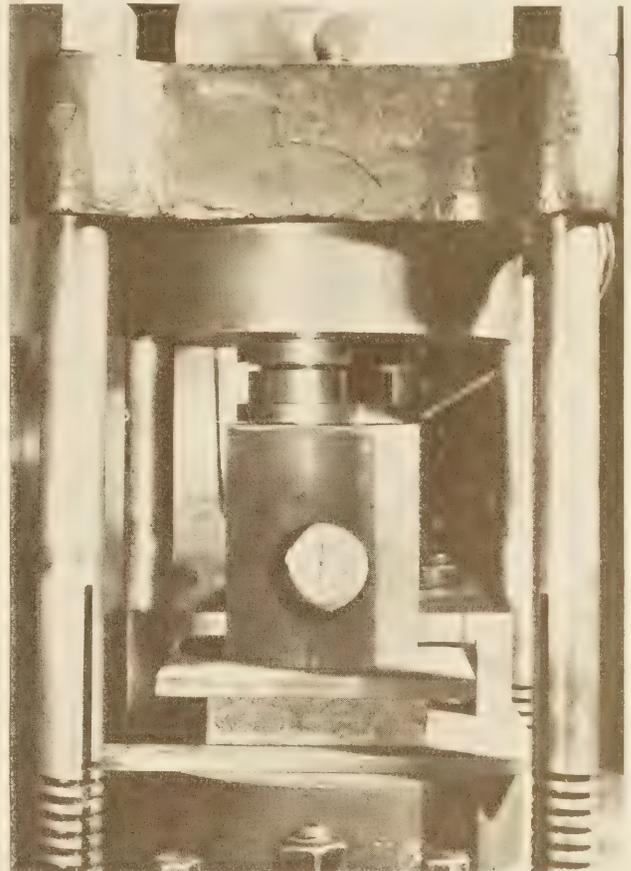
FIGURE 1.—APPARATUS FOR COMPRESSION TEST WITH EDGES FREE TO EXPAND.

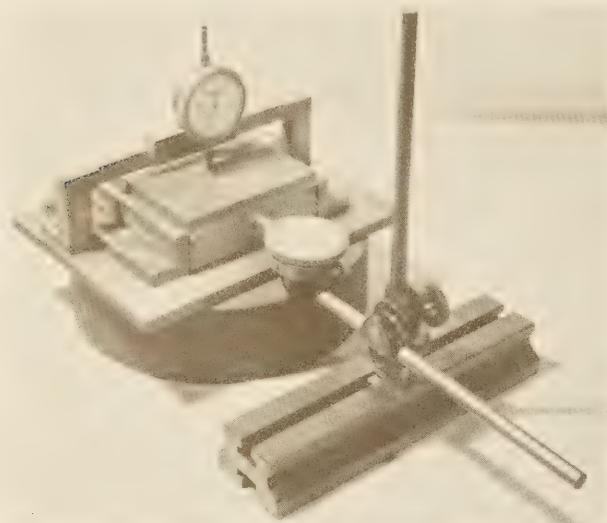
FIGURE 2.—APPARATUS USED IN EXTRUSION TEST. THREE SIDES OF THE SPECIMEN ARE RESTRAINED.

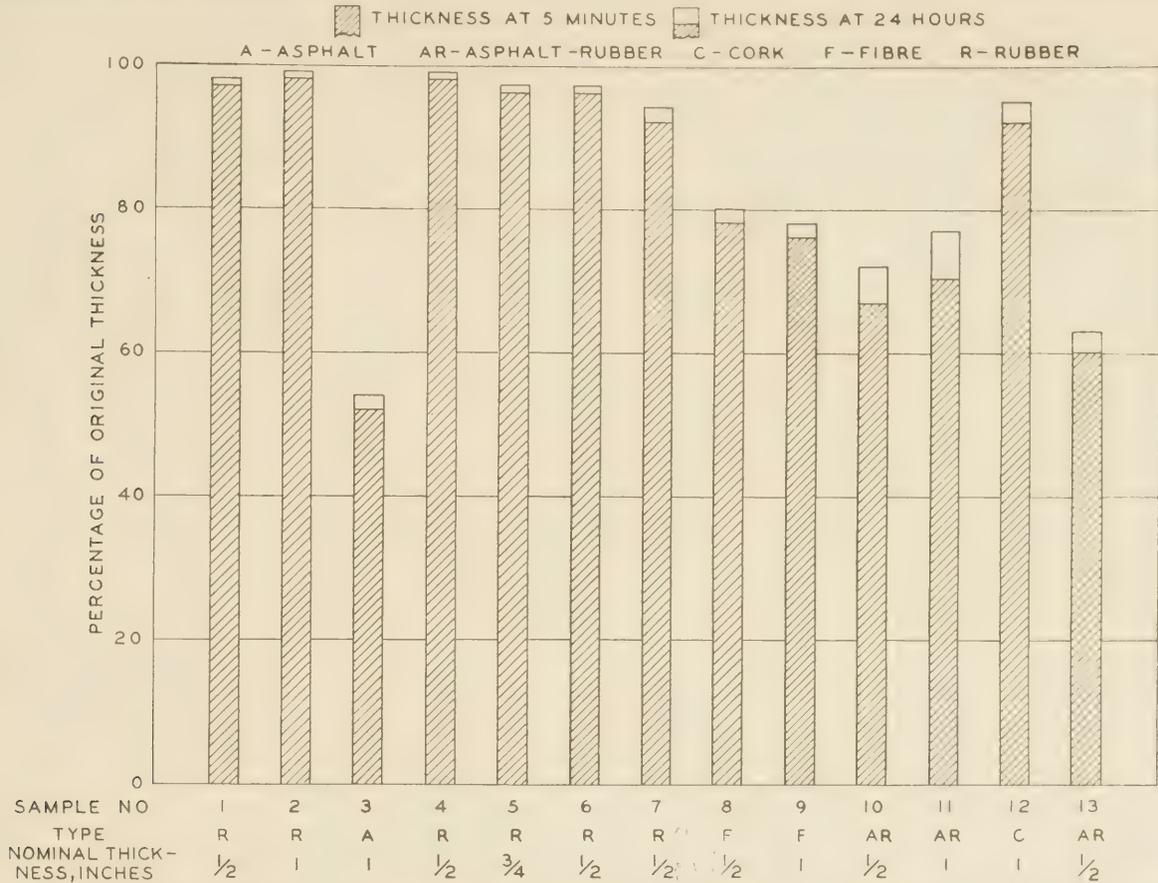
FIGURE 3.—THICKNESS OF SAMPLES AFTER THREE APPLICATIONS OF MOMENTARY COMPRESSION AND RECOVERY PERIODS AS INDICATED.

The results of the momentary compression tests are shown in figure 3. In these tests each sample was

compressed three times to one half its original thickness with the load immediately released after each compression. Rest periods of 1 hour followed each of the first two compressions and one of 24 hours followed the third compression. The several sponge-rubber fillers and the cork fillers recovered to at least 94 percent of their original thickness. The fillers of cane fiber recovered at least 78 percent of the original thickness. The fillers composed of asphalt and rubber showed varying amounts of recovery ranging from 63 to 77 percent, the filler containing the finely ground rubber, no. 13, being the least efficient. The plastic asphaltic filler showed the least recovery of any specimen, as was expected.

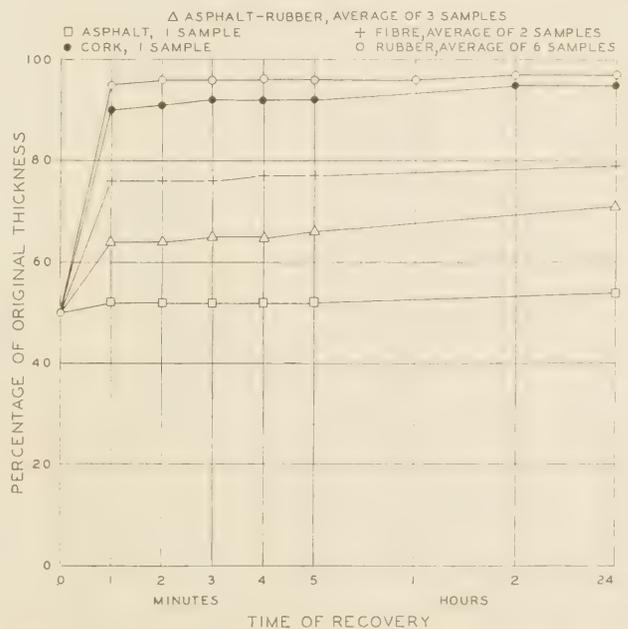
FIGURE 4.—TYPICAL TIME-RECOVERY CURVES AFTER COMPRESSION TO 50 PERCENT OF ORIGINAL THICKNESS.

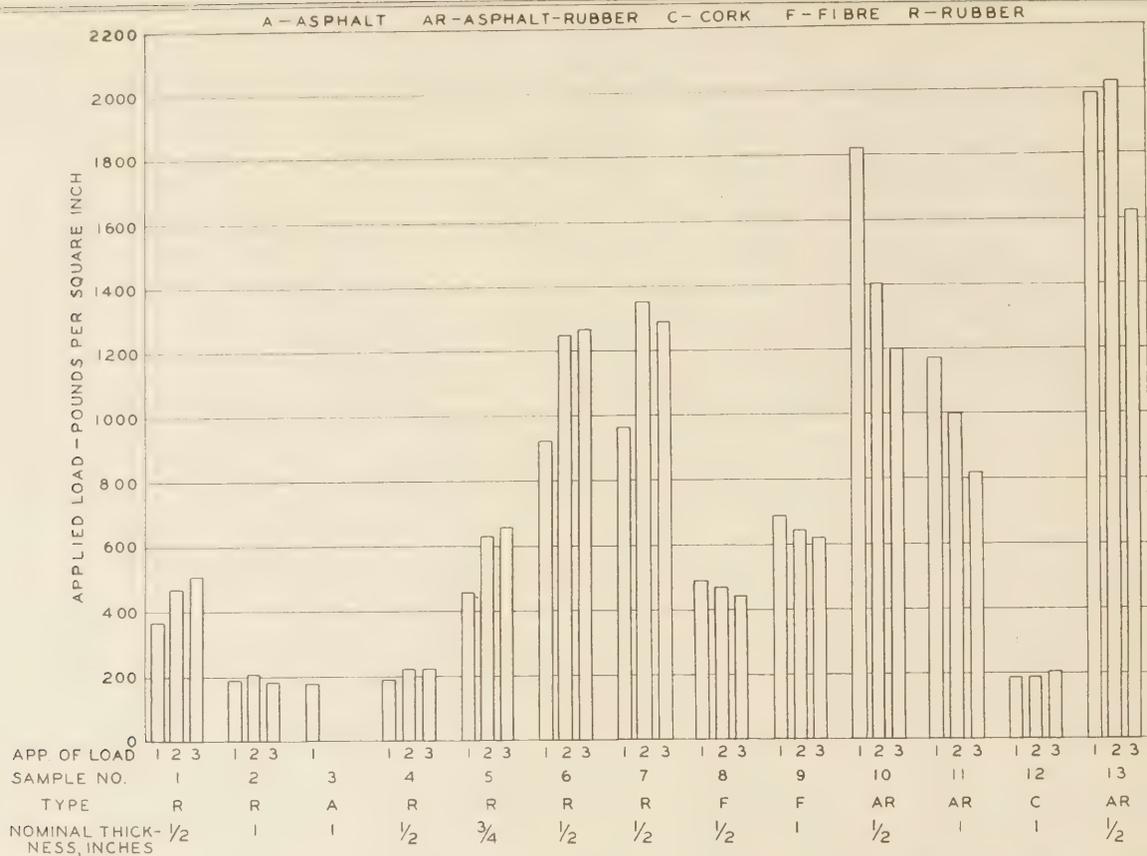
FIGURE 5.—LOAD REQUIRED TO DEFORM SPECIMEN TO ONE HALF ITS ORIGINAL THICKNESS AT EACH OF THREE APPLICATIONS OF LOAD. NO RESTRAINT AT EDGES.

Figure 5 shows the unit loads required to compress the different specimens to one half their original thickness. In several cases the load for the second and third compression was lower than for the one before it. This is accounted for by the relatively large set which occurred on the first compression. Due to this set, the material was not compressed to as great an extent on the second or third loading as on the first, and a smaller load was required. In some cases some change in the physical characteristics of the material occurred in the first compression, and a larger load was required there-

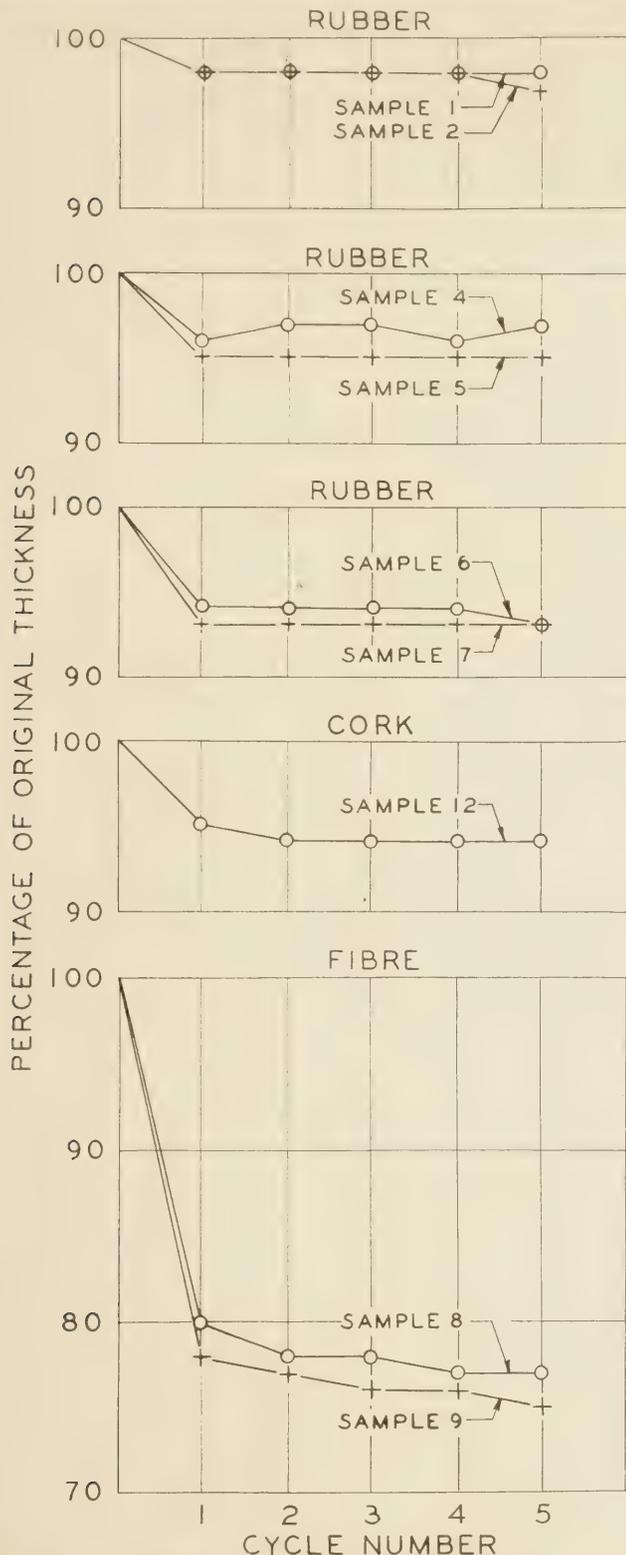
FIGURE 6.—THICKNESS AT 5 MINUTES AFTER EACH OF FIVE APPLICATIONS OF MOMENTARY COMPRESSION TO ONE HALF THE ORIGINAL THICKNESS. NO RESTRAINT OF EDGES.
